JWT C.S.C. L3507-CSC00 INSTALLATION PROCEDURE:

Why did your 350Z, 370Z, G Concentric Slave Cylinder fail?

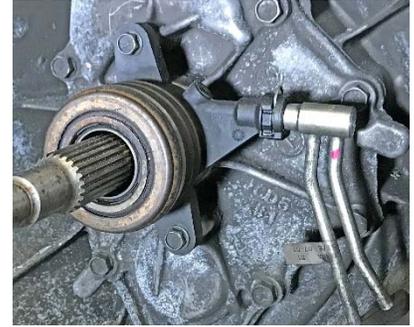
Original C.S.C.

Consistent among all of the failed samples was a large ingestion of clutch dust into the cylinder's inner sealing sleeve and ultimately passing through the hydraulic seal itself. In most cases the seal had not been damaged, but had been contaminated by large amounts of clutch dust which would eventually lift the seal off of the sleeve allowing fluid to escape to the exterior of the cylinder. On many of the failed cylinders this condition was expedited by distortion of the plastic piston / seal support used as a substitute for a more appropriate metal piston / seal support as a cost saving measure.

JWT has designed a new direct fit C.S.C. that addresses both issues with the O.E. cylinder by incorporating an all-aluminum piston / seal support featuring 2 full radial PTFE sleeve wipers dramatically reducing friction and clutch dust migration to the seal. The JWT C.S.C. is a direct fit replacement for the original C.S.C. using all of the original factory hydraulic lines and fittings with no modifications or additional hoses, simply install the same as a stock C.S.C.

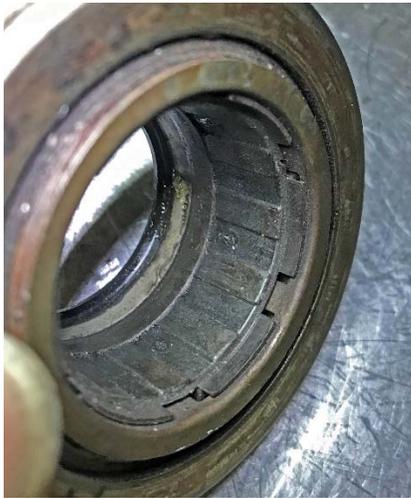
Axial slots directly exposing the seal to clutch dust.

It was glaringly obvious that 12 axial grooves on the inside diameter of the plastic piston were allowing clutch dust to migrate from the front of the cylinder to the seal at the back end of the piston and ultimately across the seal resulting in the pattern failure seen on the sample cylinders. This design of 12 axial grooves in the sliding surface correctly decreased the sliding friction as intended but myopically failed to mitigate the propagation of clutch dust into the seal itself!

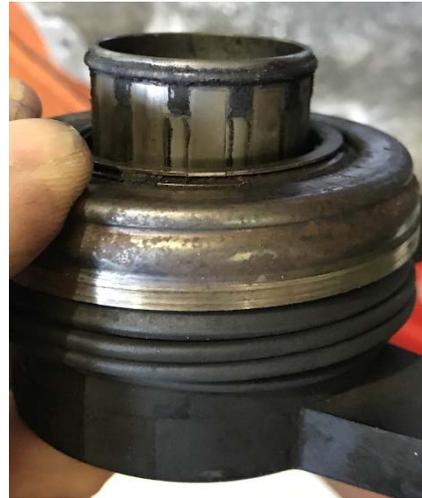
Clutch dust built up along the 12 axial slots.
