SPEARCO 84-87 300ZX INTERCOOLER PIPE LAYOUT

Routing of the Intercooler Pipe

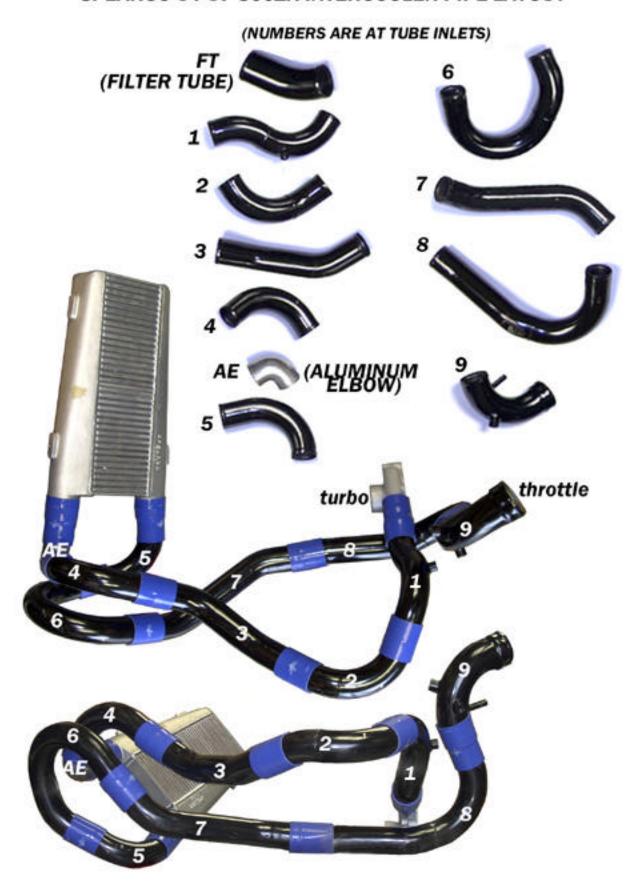
It is necessary to follow the exact sequence of the installation of the tubing, otherwise it may increase the difficulty and installation time.

- **A.** Slide number **#6 tube** in from the bottom, hooking it up over the top of the radiator. The straight end goes toward the intercooler, the curved end goes topside.

- **B.** Connect **#6 tube** to **#5 tube** with hose and clamps and mount to the bottom of the intercooler with reducing hose and clamps.
- **C.** Assemble **#4 tube** to **AE** (aluminum elbow) and slide them up from the bottom and hook over the top of the radiator. Connect **AE** to the intercooler with reducing hose and clamps. Orient the hose clamps so that they are pointing forward so that they can be tightened with a small ratchet. (Do not fully tighten at this time).

- **D.** Install **#7 tube** by slipping it down beside the radiator shroud, and pushing it toward the rear beneath the air flow meter and connect it to the **#6 tube** with the hose and clamps provided.

- **E.** Install **#8 tube** by sliding it down into the engine compartment between the shock tower and the engine and behind the air conditioning compressor. Connect it to **#7 tube** with the hose and clamps provided.

- **F.** Install **#1 tube** into position and connect it to the turbocharger outlet using the clamps and reducer hose provided.
- G. Connect #2 tube to #1 tube.

- **H.** Install the **#3 tube** over the radiator shroud and connect it between the **#2 and #4 tubes**. Position clamps with screws on top so they can be easily tightened.

- I. Now connect #8 tube to #7 tube and install the remaining #9 tube between the #8 tube and the throttle body.
- **J.** Connect the existing PCV and Idle by-pass hoses.

- **K.** Adjust the tubes for proper clearance; make certain there is sufficient clearance between the air conditioning pulley and the #2 tube. Tighten all clamps and inspect your work.
