JWT C.S.C. L3507-CSC00 INSTALLATION PROCEDURE:

Why did your 350Z, 370Z, G Concentric Slave Cylinder fail?

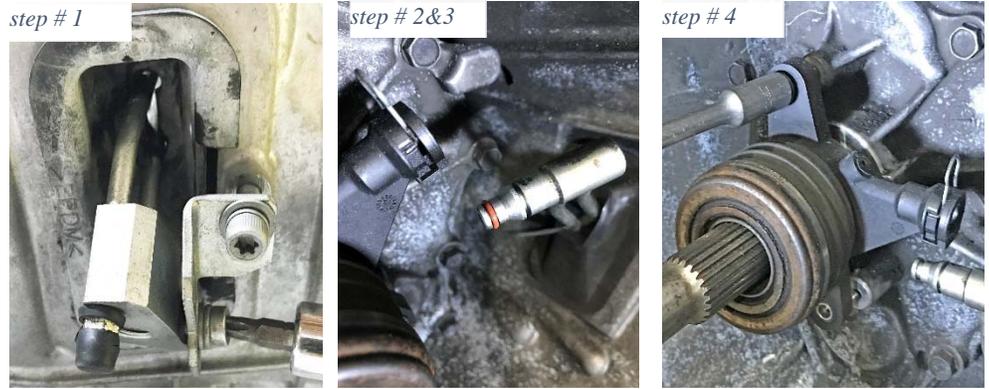
1. With the transmission removed, loosen both bolts on the hydraulic tube mounting bracket on the outside of the bell housing.
2. Remove the wire clip holding the hydraulic tube into the original C.S.C. and pull the hyd. tube out of the C.S.C.

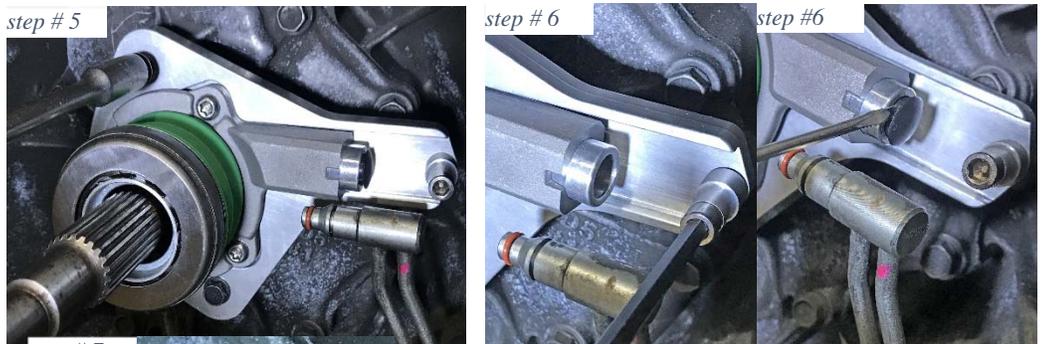
5. Install the new JWT C.S.C. using the original 2 C.S.C. mounting bolts.
6. Remove the hydraulic tube retaining bolt and spacer (if attached) and the black plastic protector from the hydraulic port.

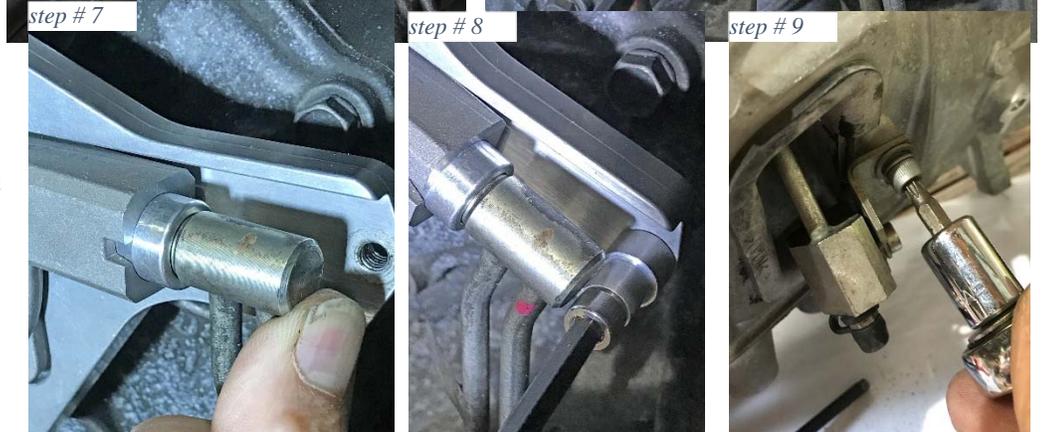
7. Install the hydraulic tube end with new O-ring into the C.S.C. hydraulic port, insuring it is fully seated in the C.S.C.

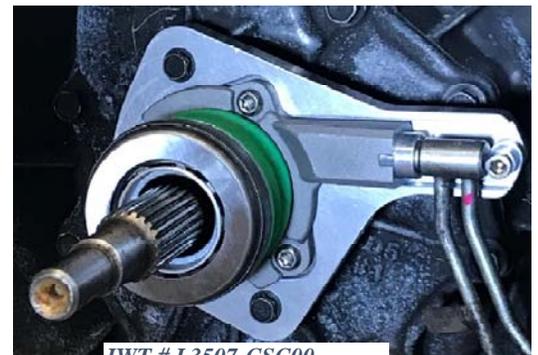
JWT # L3507-CSC00

JWT has designed a new direct fit C.S.C. that addresses both issues with the O.E. cylinder by incorporating an all-aluminum piston / seal support featuring 2 full radial PTFE sleeve wipers dramatically reducing friction and clutch dust migration to the seal. The JWT C.S.C. is a direct fit replacement for the original C.S.C. using all of the original factory hydraulic lines and fittings with no modifications or additional hoses, simply install the same as a stock C.S.C.
